PYRAMID GEOPHYSICAL SERVICES  
(PROJECT 2017-253)

# GEOPHYSICAL SURVEY

METALLIC UST INVESTIGATION:  
PARCEL 5  
NCDOT PROJECT P-5705B (44475.1.2)

601 W. TRADE ST., CHARLOTTE, NC

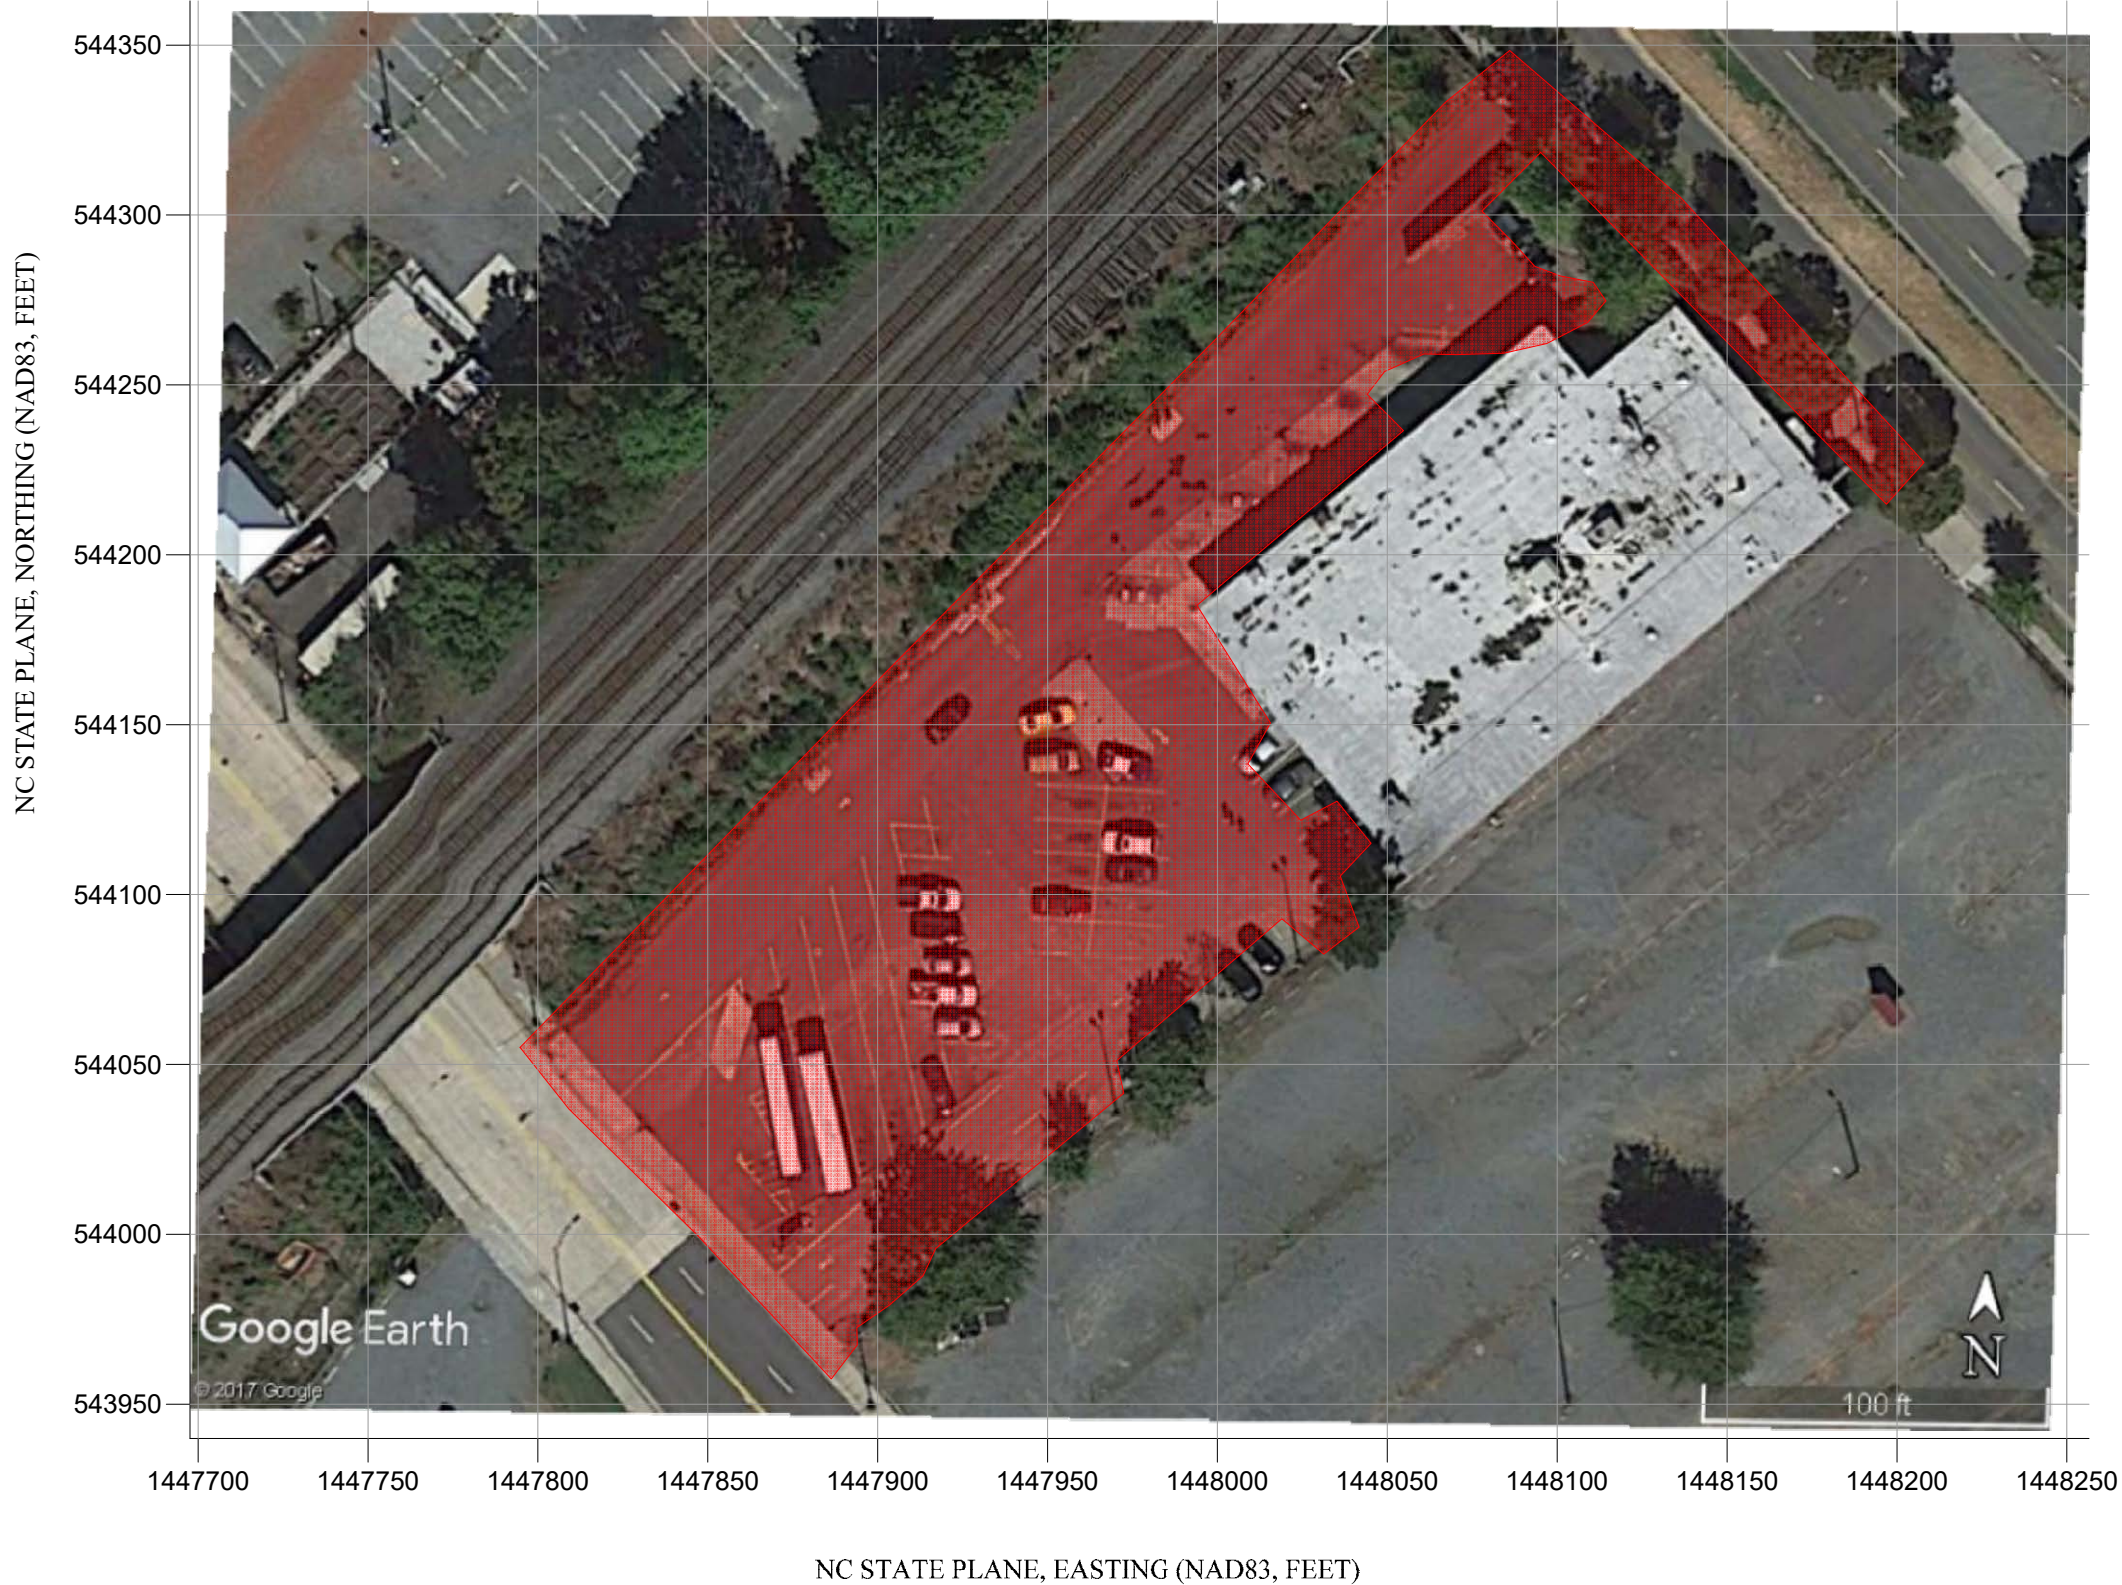
APPROXIMATE BOUNDARIES OF GEOPHYSICAL SURVEY AREA

The site included a commercial bus depot surrounded by asphalt parking areas. The location of the known UST was evidenced by a concrete pad and fill ports. It should be noted that large portions of the site were inaccessible due to parked vehicles, which also resulted in widespread metallic interference during the EM survey (see Discussion of Results below). An aerial photograph showing the survey area boundaries and ground-level photographs are shown in **Figure 1**.

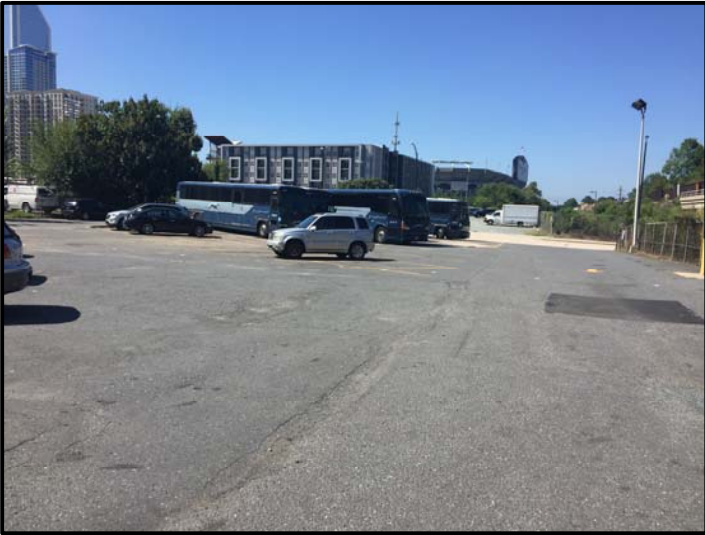
View of Survey Area  
(Facing Approximately Southwest)

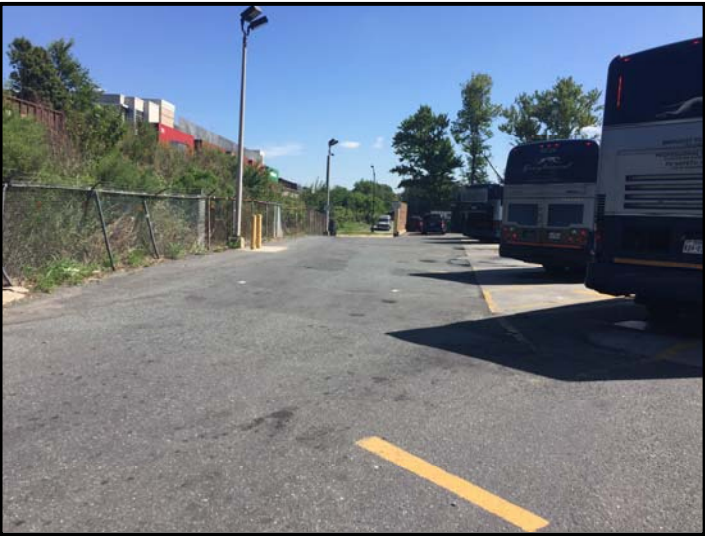
View of Survey Area  
(Facing Approximately Northwest)

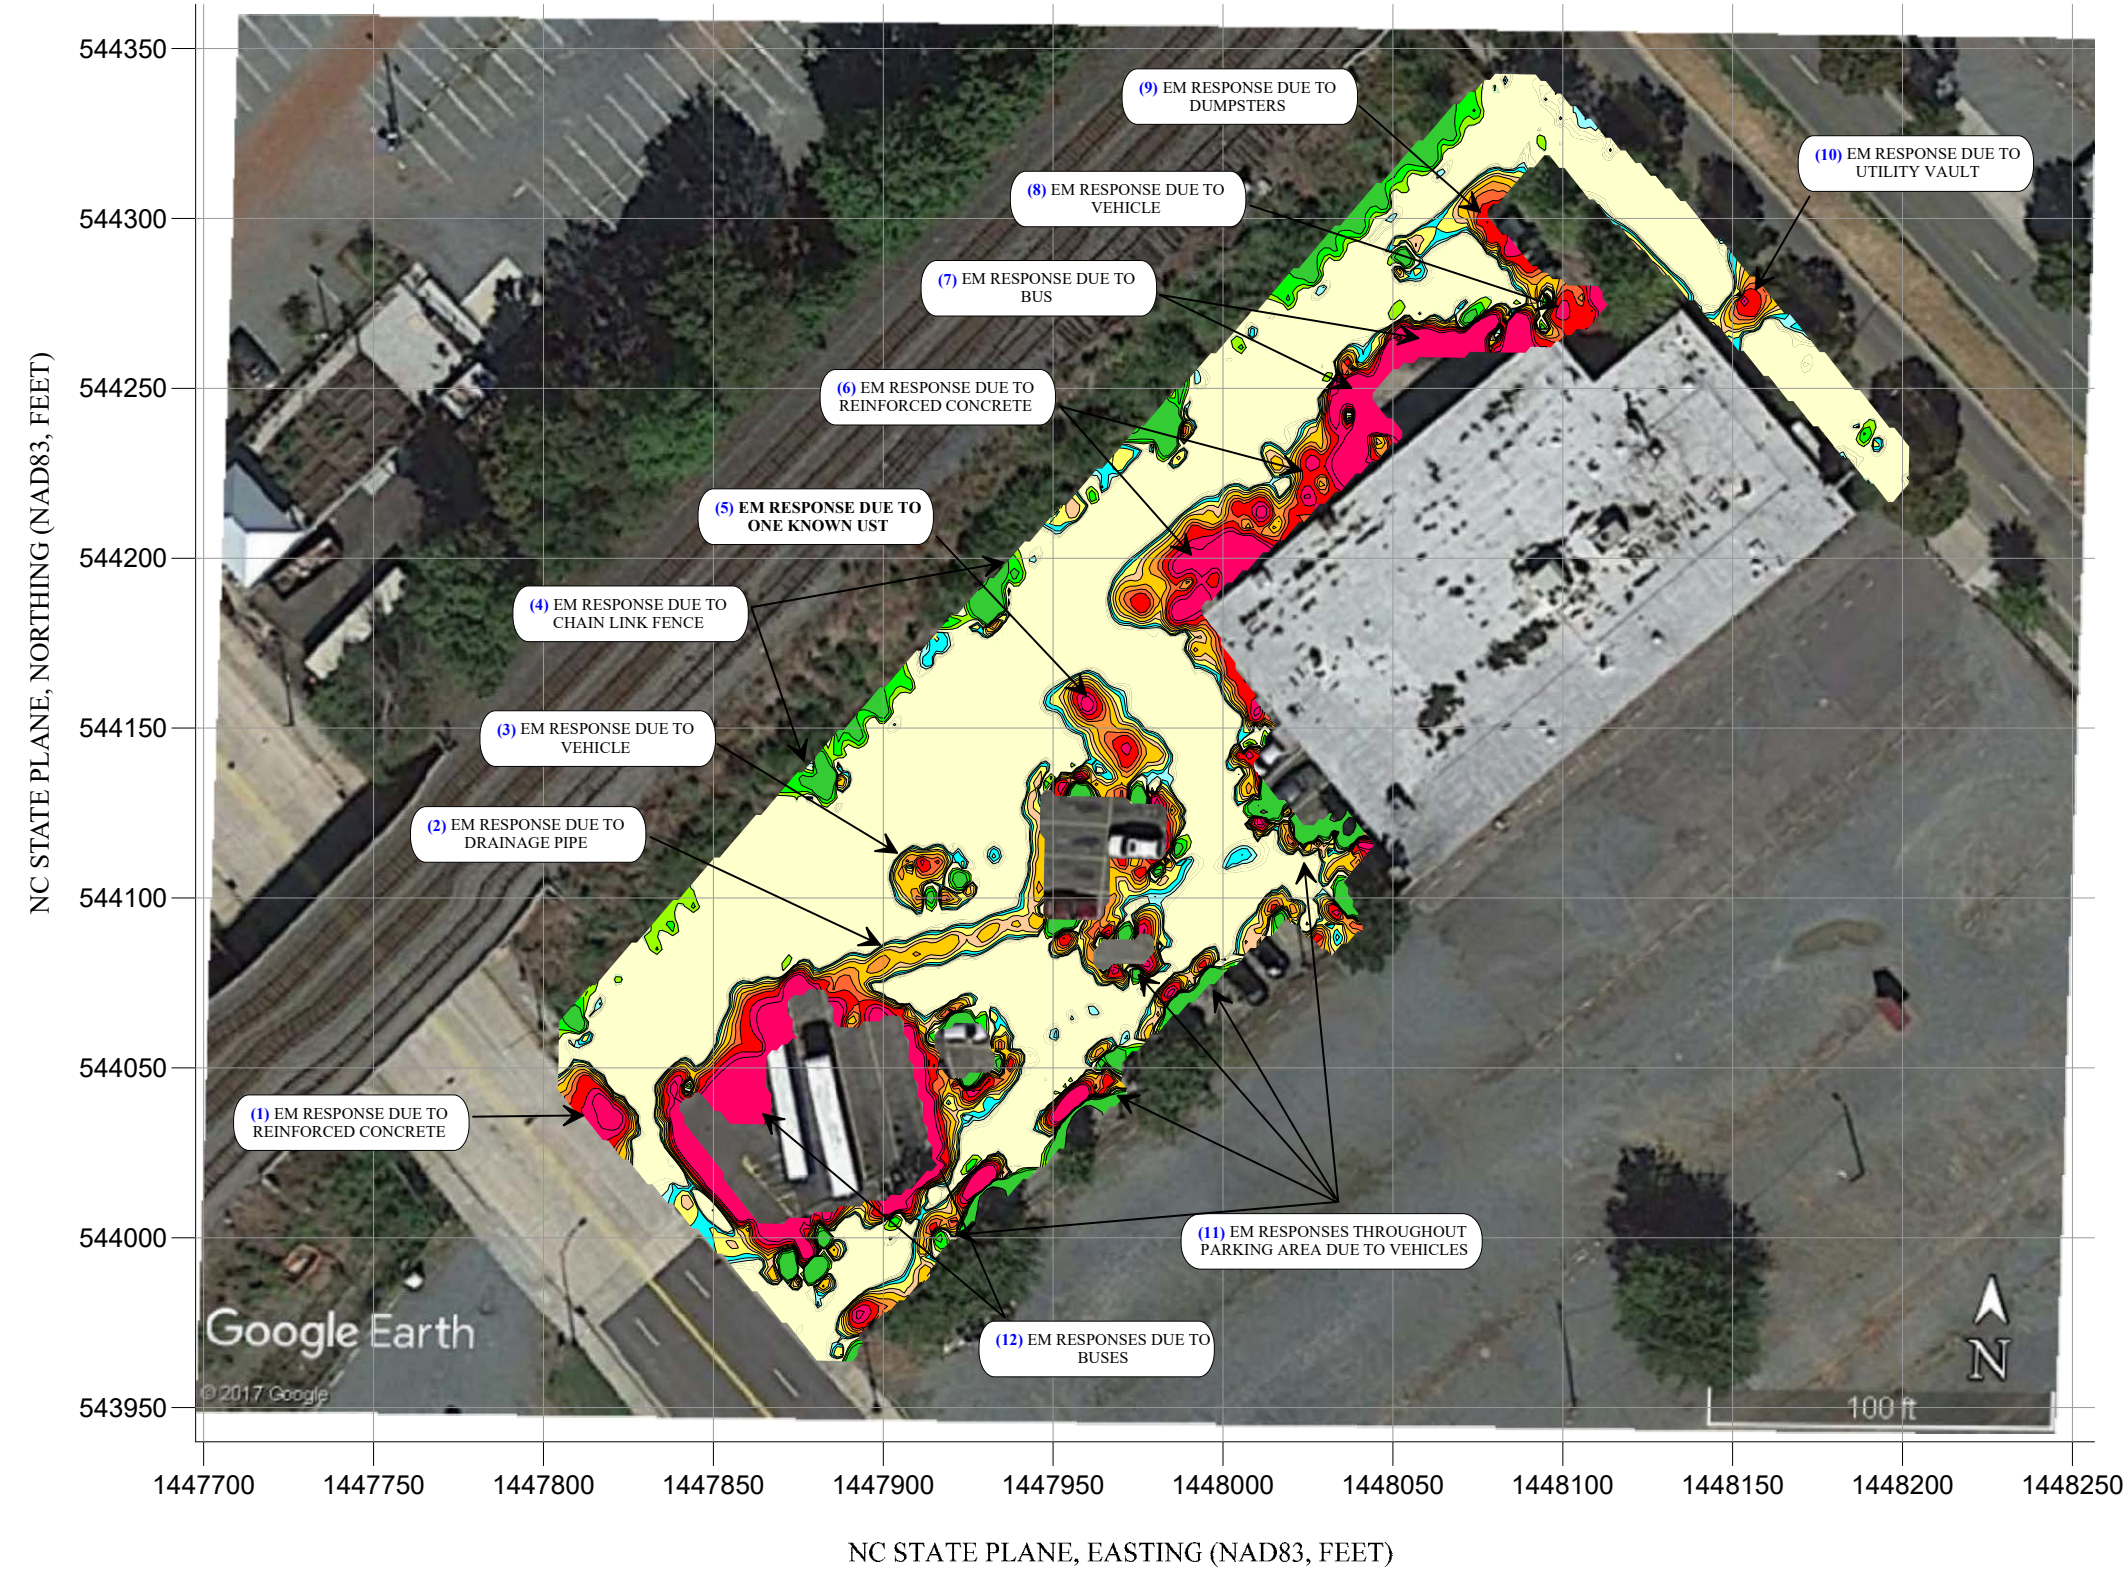
EM61 METAL DETECTION RESULTS

A contour plot of the EM61 results obtained across the survey area at the property is presented in **Figure 2**. Each EM anomaly is numbered for reference in the figure. The

The majority of the EM anomalies were the result of known cultural features including reinforced concrete, a drainage pipe, abundant vehicles and buses, a chain link fence, dumpsters, and a utility vault. Anomaly 5 was associated with the known UST. GPR was performed to verify the extents of the known UST, as well as to examine areas suspected to contain reinforced concrete and to verify the drainage pipe location (Anomaly 2). Additionally, GPR was performed in accessible areas between vehicles where EM data were not collected.

EVIDENCE OF ONE KNOWN METALLIC UST OBSERVED.

The contour plot shows the differential results of the EM61 instrument in millivolts (mV). The differential results focus on larger metallic objects such as USTs and drums. The EM61 data were collected on August 18, 2017, using a Geonics EM61 instrument. Verification GPR data were collected on August 18, 2017, using a GSSI UtilityScan DF unit with a dual frequency 300/800 MHz antenna.

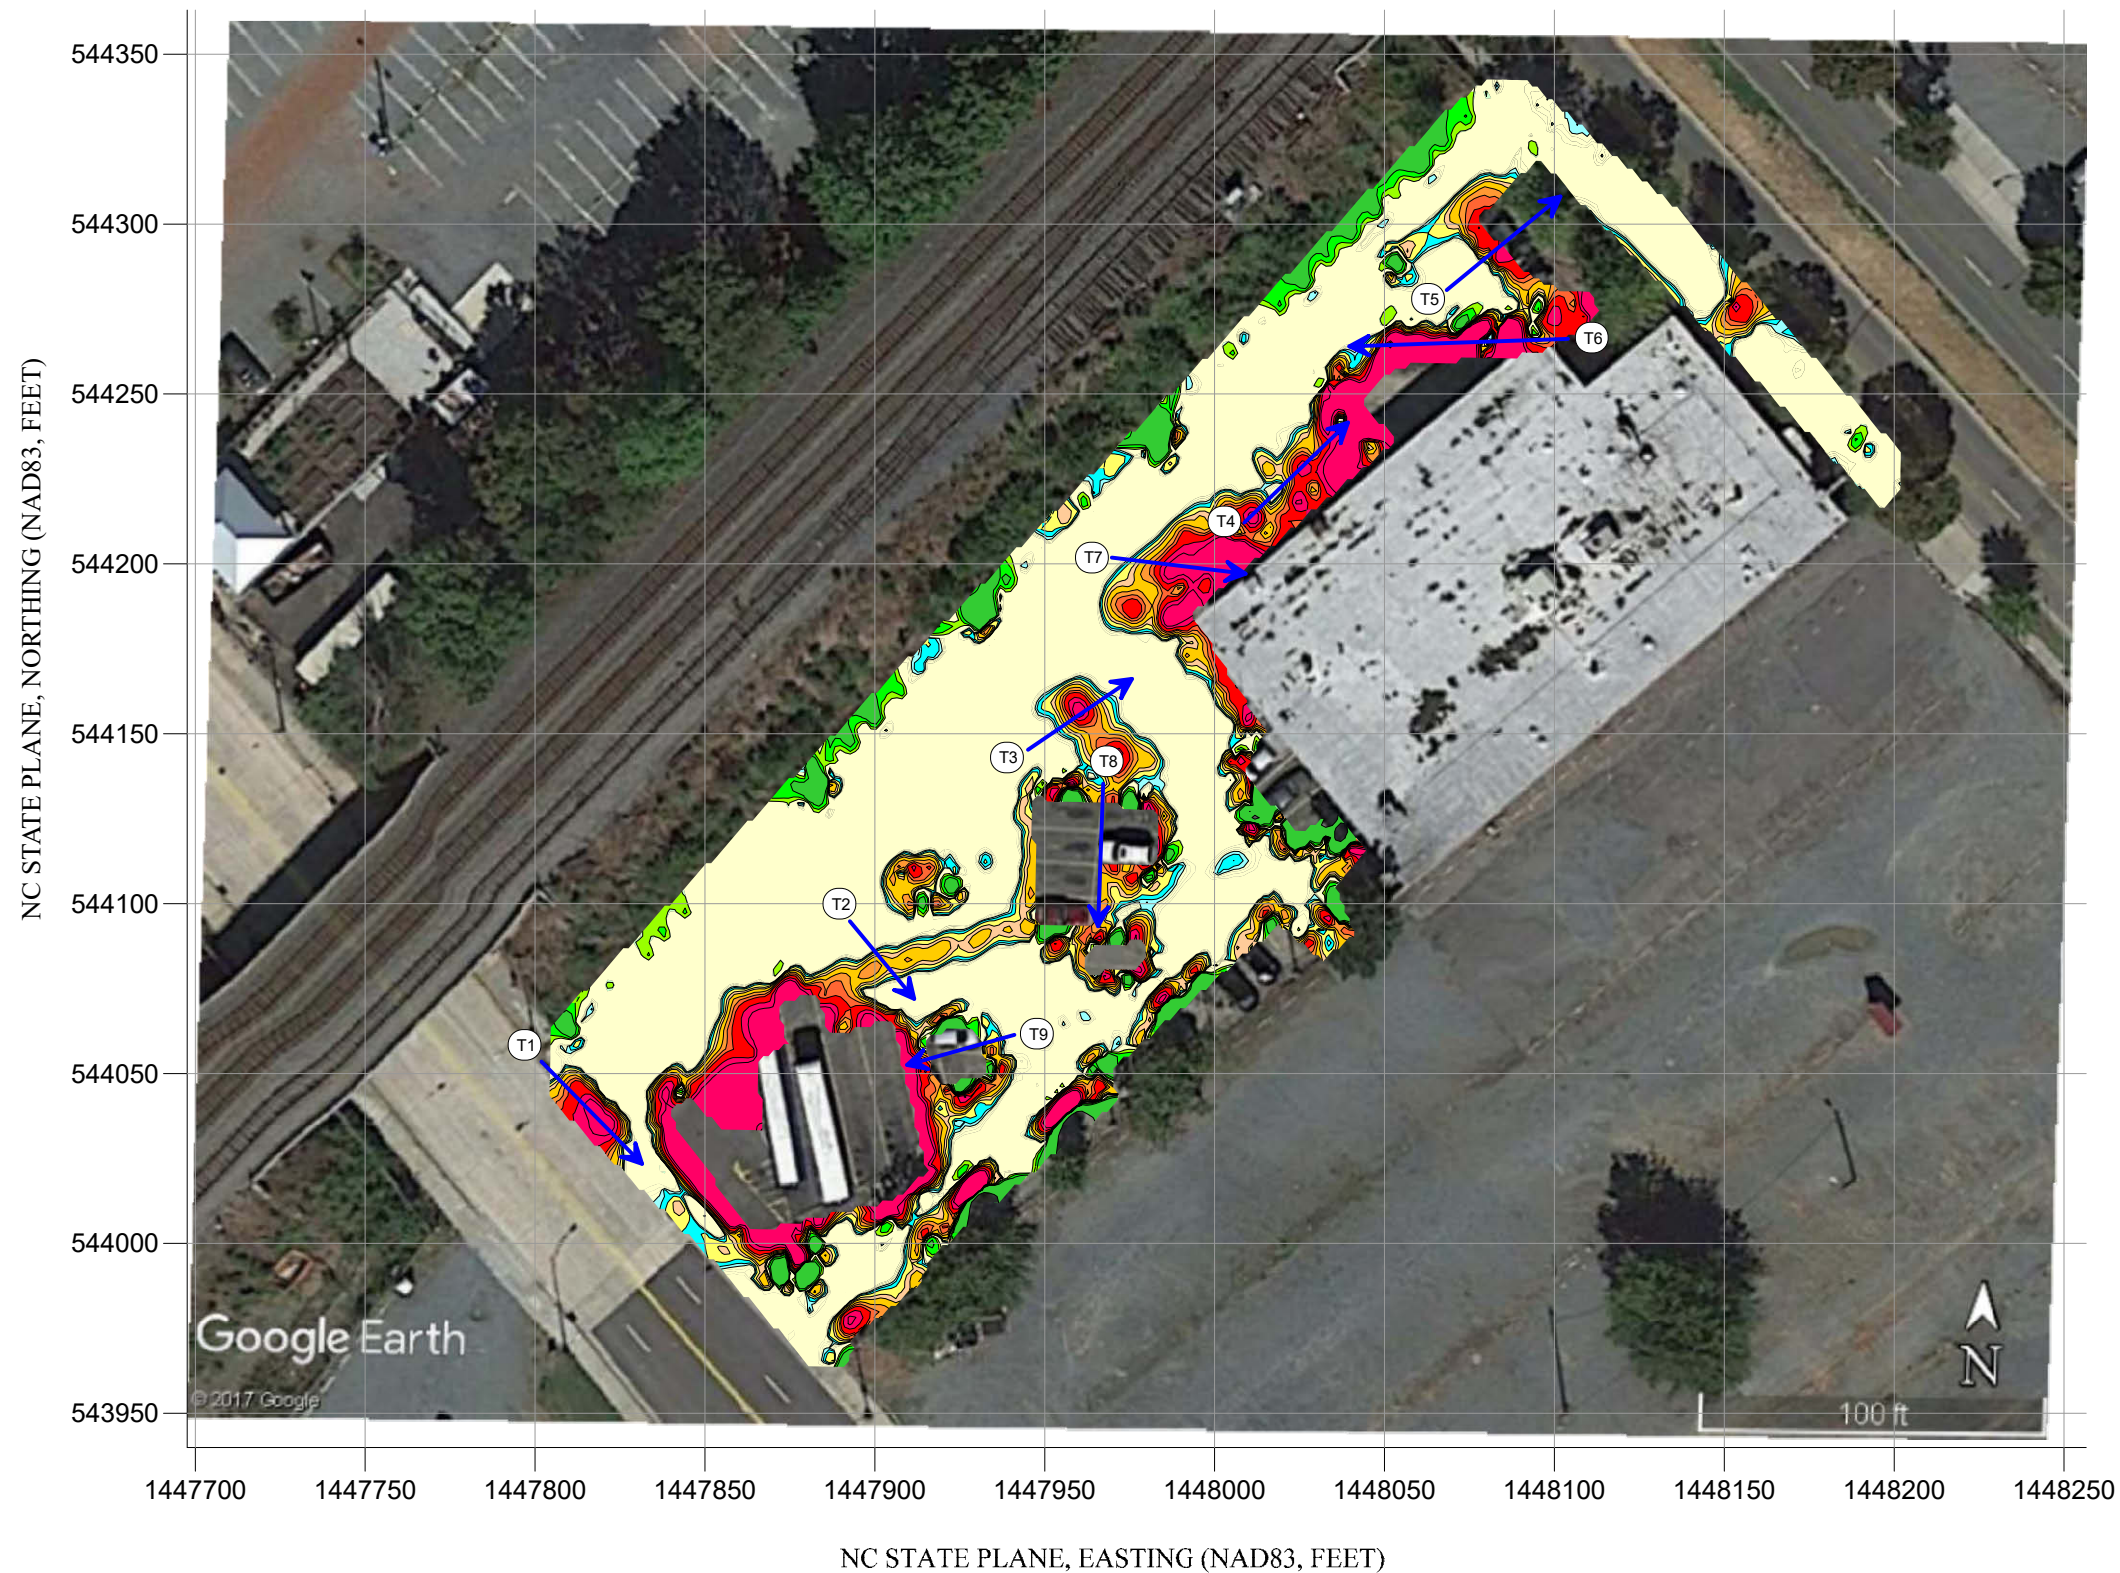
### GPR TRANSECT LOCATIONS

**Figure 3** presents the locations of the formal GPR transects performed at the property, as well as select transect images. All of the transect images are included in **Appendix A**. A total of nine GPR transects were performed at the site. GPR Transects 1, 4 and 7 were all performed across areas suspected to contain metal-reinforced concrete. These transects verified the presence of reinforcement, and did not record any evidence of larger structures such as USTs underlying the reinforcement.

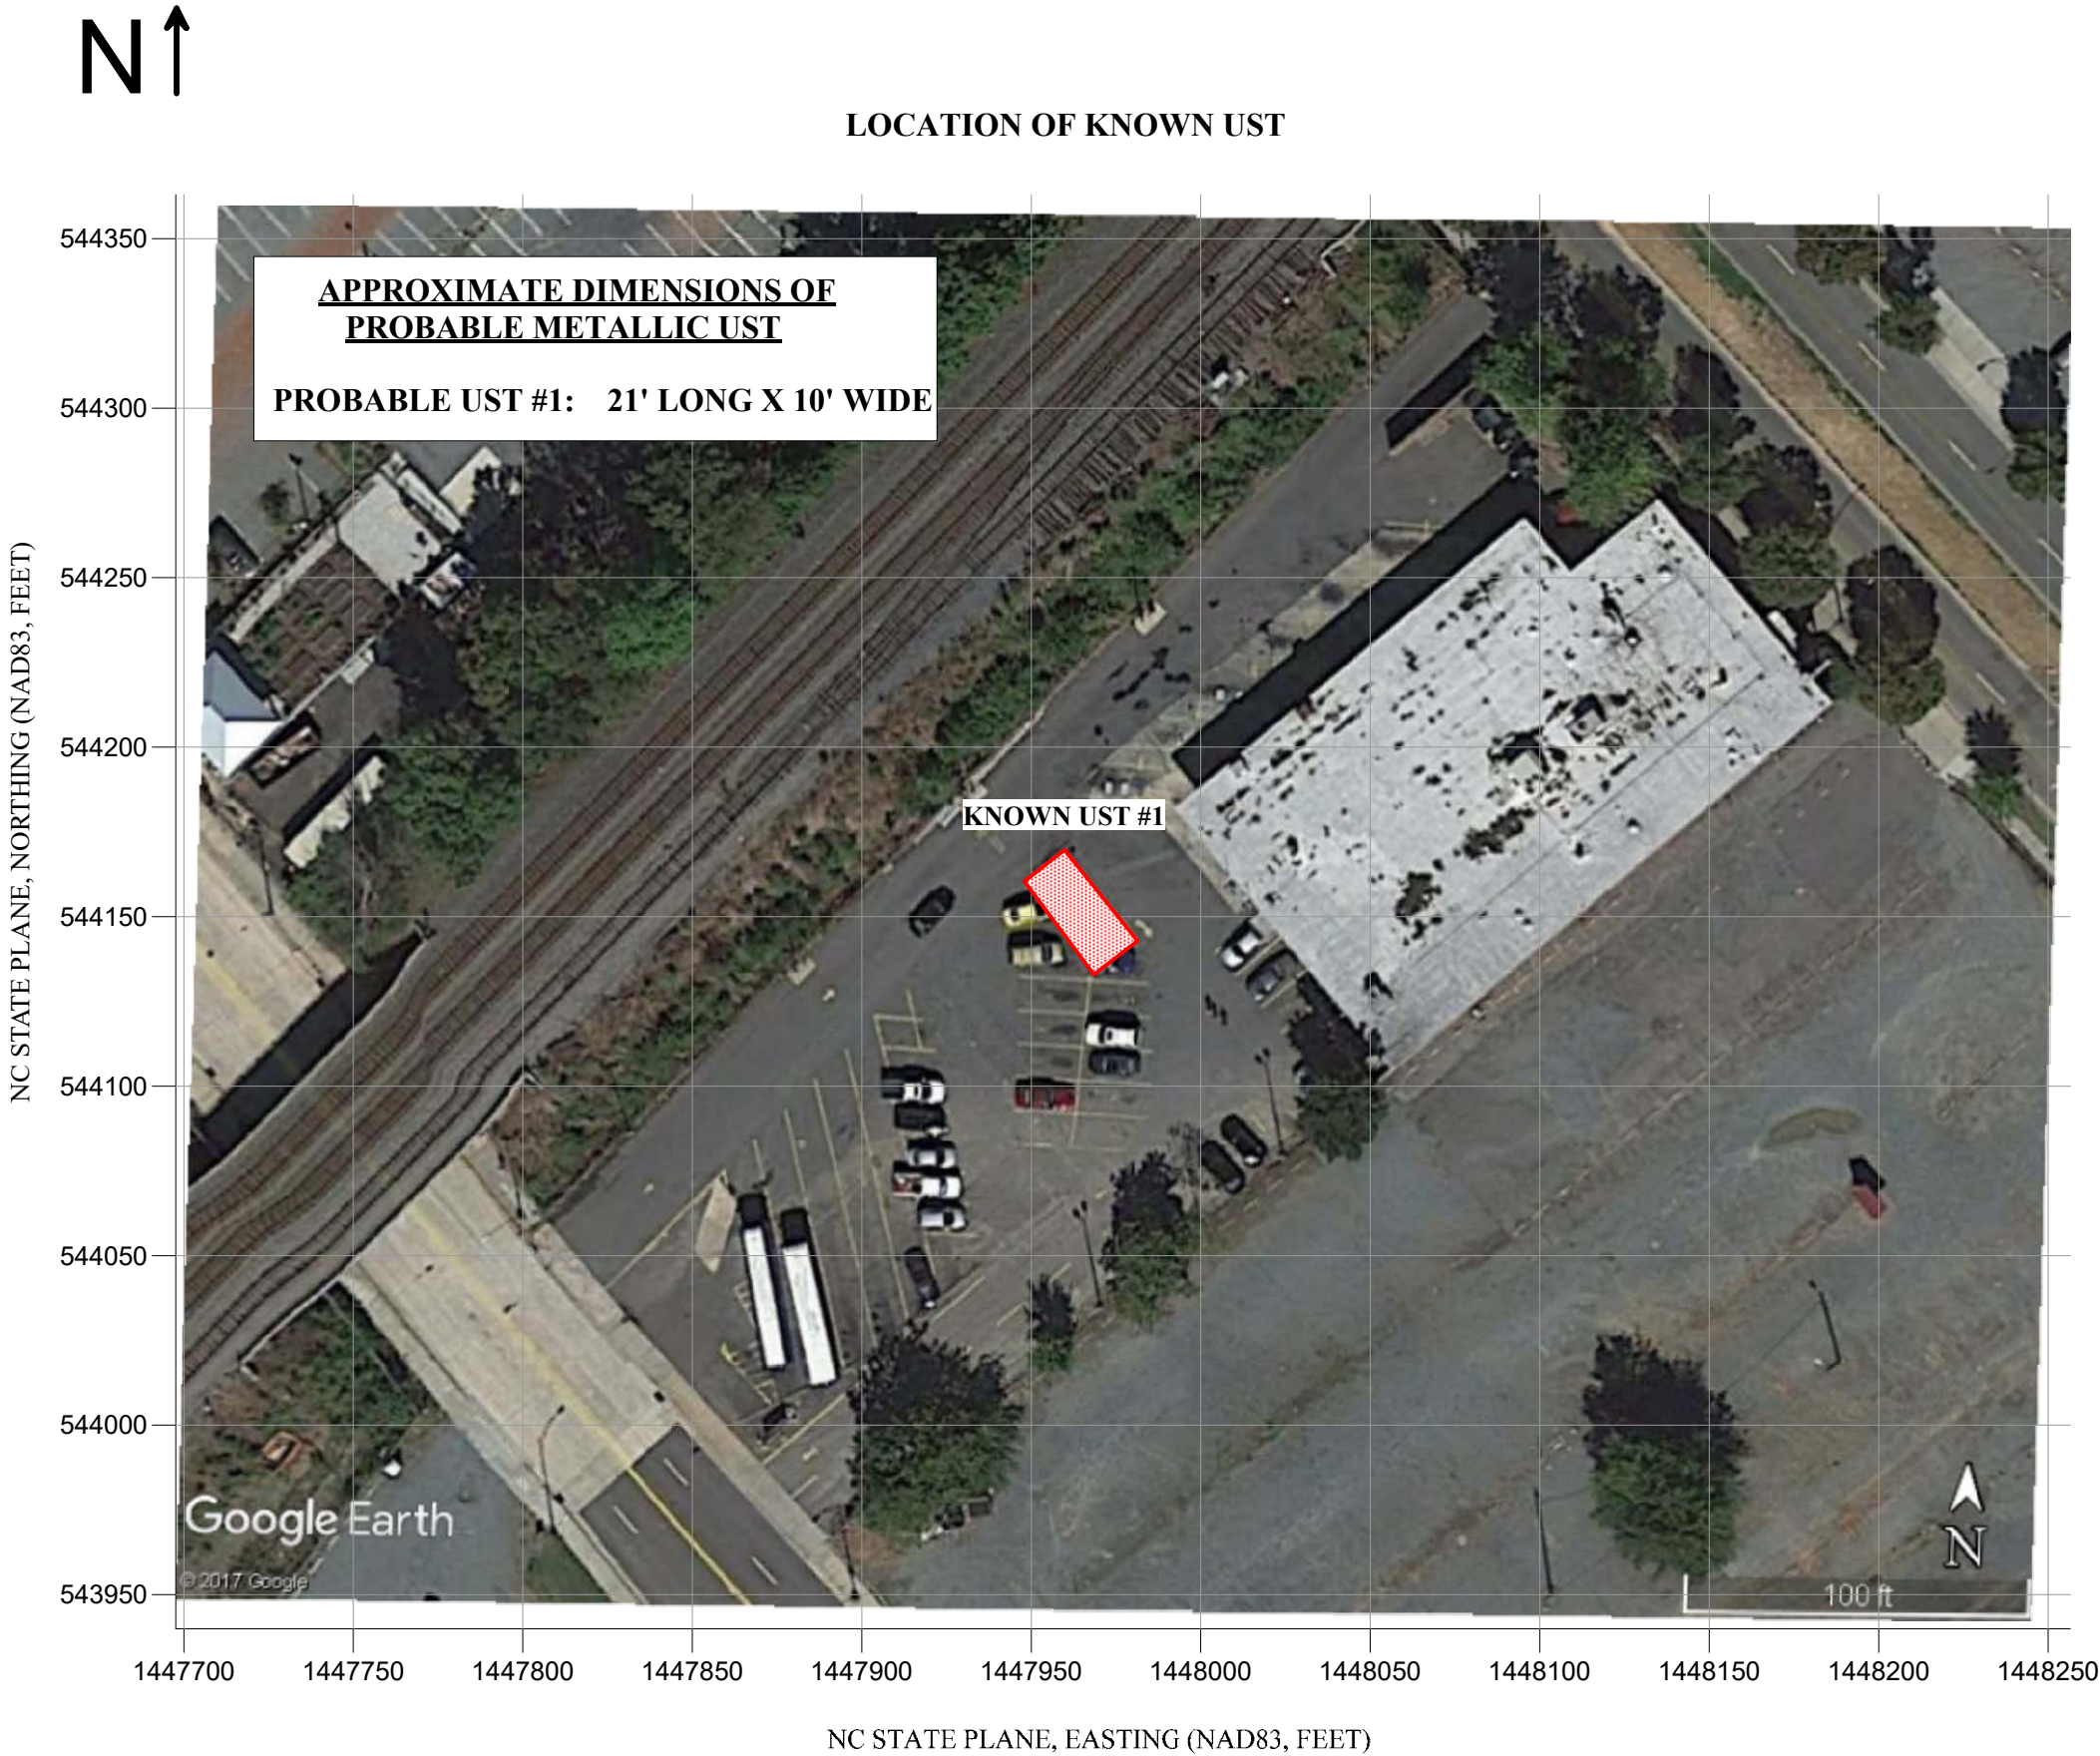
View of Known UST #1  
Facing Approximately Southeast

GPR Transect 2 verified the presence of a buried storm drain pipe crossing through the parking lot (Anomaly 2). GPR Transect 3 was performed across the width of the known UST, verifying that this tank was contained within the observed concrete pad in the parking area. The known UST was approximately 21 feet long and 10 feet wide at a depth of approximately 2.5 feet below the ground surface (center point of tank: 1447965, 544149; North Carolina State Plane NAD83, feet).

**Figure 4** presents the location of the known UST along with a ground-level photograph. **Figure 5** provides an overlay of the geophysical survey areas and the known UST onto the NCDOT MicroStation engineering plans for reference.
